ASBESTOS CEMENT ROOF - OVER-ROOFING

## CASE STUDY

### Reel Service

## ASBESTOS CEMENT ROOF - OVER-CLADDING CASE STUDY REEL SERVICE

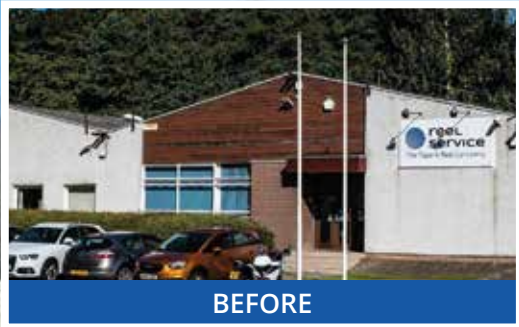
BEFORE

Reel Service engaged IRS after a number of years of constant water ingress.

The ongoing cost to repair Persistent Roof leaks and damaged internal stock was the catalyst for Reel Service to consider a long term solution to their ageing roofs.

Reel Service considered removing the existing Roof and replacing with a new roof, however due to ongoing operations a decision was reached to Over-Clad the existing Asbestos Cement Roof with a new Over Roofing System and additional insulation.

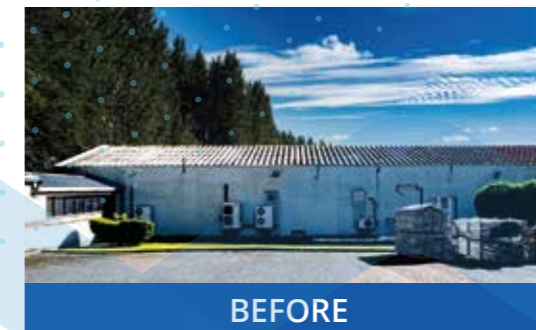
BEFORE

- Years of accumulated Roof vegetation was removed/cleaned from roof.
- Sacrificial netting was laid over asbestos roof to prevent falls through the fragile Roof.
- Breather membrane was laid out.
- A light gauge spacer bar system was installed.
- Insulation was rolled out to help increase buildings thermal value.
- New Metal Roof Cladding was installed to the new Spacer Bar System.
- Closure trims and flashings were installed to ensure wind and water tightness of the new Over-Roofing System.
