Sainsbury's Distribution Centre

## CASE STUDY

### GUTTER LINER

After years of water ingress, spiralling repair bills and loss of stock - Sainsbury's decided it was time to take action with their failing gutters at their distribution centre in Scotland

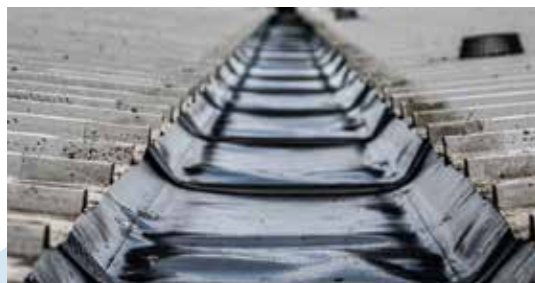
AFTER

Sainsbury's considered a number of options to resolve the ongoing gutter issues, HD Sharmans "Plygene gutter lining system" was the chosen solution.

- The gutters were cleaned out in preparation for the new gutter lining system.

- The new "Plygene" liners were rolled out and fitted into the existing gutter profile.

- The liners were mechanically fixed into the gutters using stainless steel roof fixings.

- Wind uplift straps were installed as per manufacturers guidelines.

- Syphonic Outlets/Stopends were installed using heat welding process.
